Outlet Home Inspections

Property Address:

123 Main St, Jersey City, NJ

1 Report Information

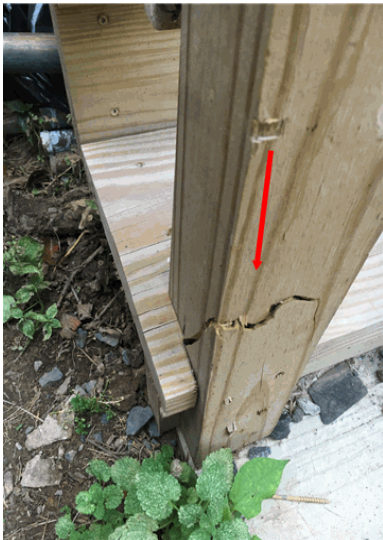
5) Back Entrance Conditions R The railing post on the wooden deck was found to be cracked and should be repaired. It is suggested that a "Licensed General Contractor" be contacted for further evaluation and repair.

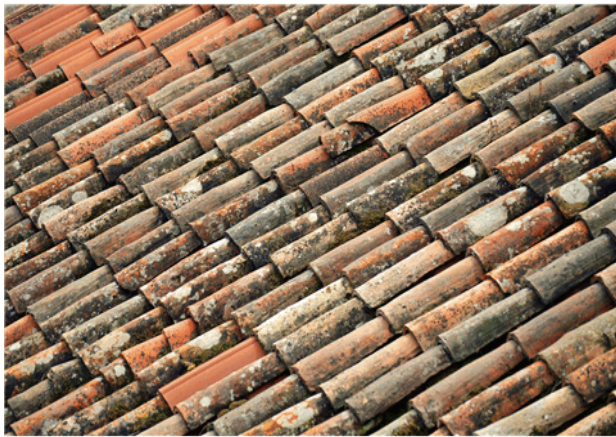
Method of Inspection	The roof was inspected by combination of viewing with high power binoculars and from placing ladder up against the gutter.
Roof Style	Gable.
Roof Covering Material	Clay Tile.
Number of Layers	One.
11) Roof Covering Condition	<div>R</div> <p>The roof covering showed signs of aging and requires some maintenance and/or repair. This condition generally indicates that the roofing materials are approaching or close to the end of their useful life. Although immediate replacement may not appear necessary now, we recommend maintenance be performed on a regular basis with annual inspection by a qualified roofing contractor. The inspector cannot offer an opinion as to whether the roof leaks today unless it is moderately raining at the time of inspection. Client should obtain full disclosure / history information from the seller prior to close.</p>

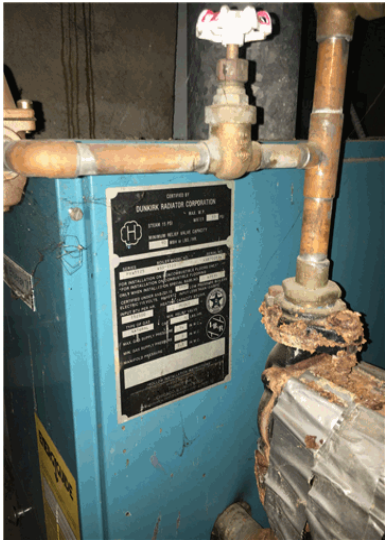
16) Unit Conditions R The system is older and appears to be past its normal life expectancy. Client should consider replacement with a modern unit conforming to modern safety standards and efficiency in the near future.

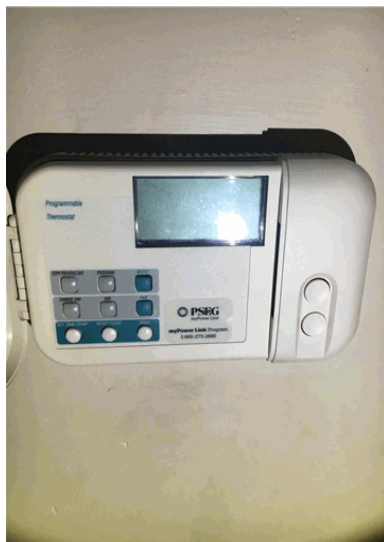
19) Thermostat Condition R The thermostat was broken and inoperable during the inspection. Recommend repair or replacement.

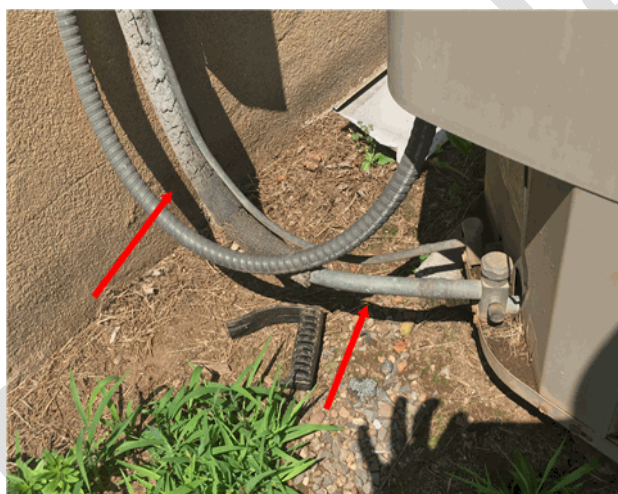
The insulation on the refrigerant lines was deteriorated and partially missing. Recommend replacing this rather inexpensive pipe insulation to improve efficiency.

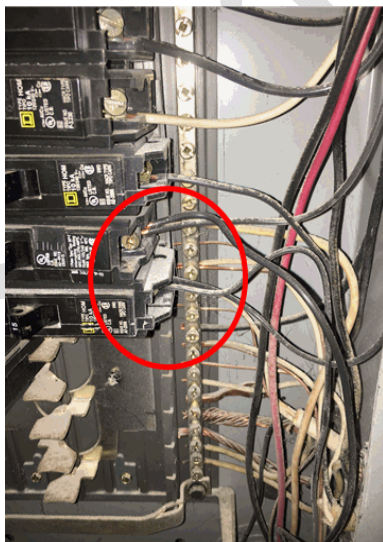
23) Electrical Panel Conditions R Two or more wires were connected to one breaker in the panel. This condition can add to the load of the affected electrical circuit(s) causing a possible overload, tripping, or arcing at the breaker(s). Current standards require circuits to be independently protected. Recommend an electrician properly separate circuits.

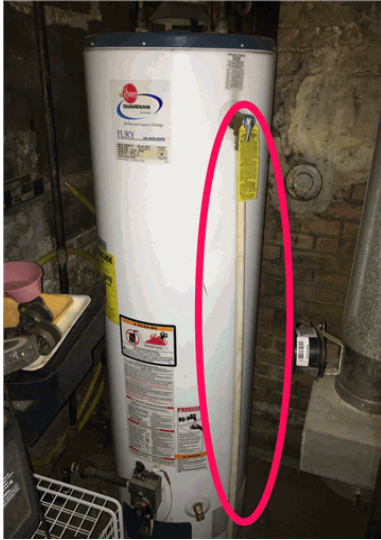
- Water Heater Type** Natural Gas.
- Water Heater Location** Basement.
- Water Heater Capacity** 50 Gallon.
- 28) Water Heater Conditions** S T P R (temperature pressure relief) valve overflow pipe was improperly installed as a plastic pipe. Recommend installation of a metal pipe for increased safety. Client should consult a licensed plumber for additional information.

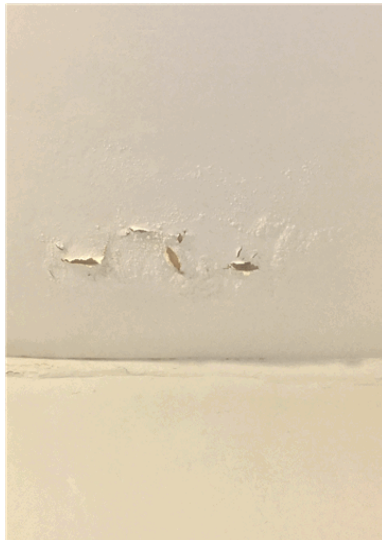
Moisture related stains were observed at the bathroom ceiling. This was most likely caused by a leak from the top floor shower tub. Please refer to limitations of inspection regarding mold / moisture related conditions.

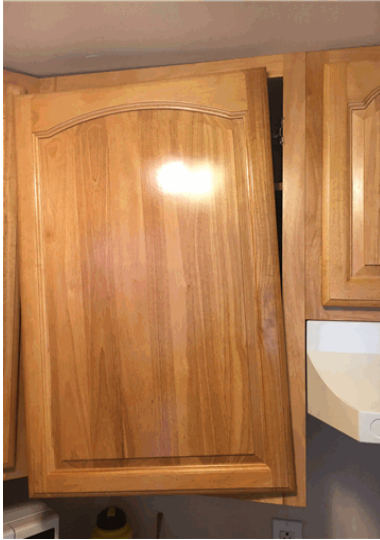
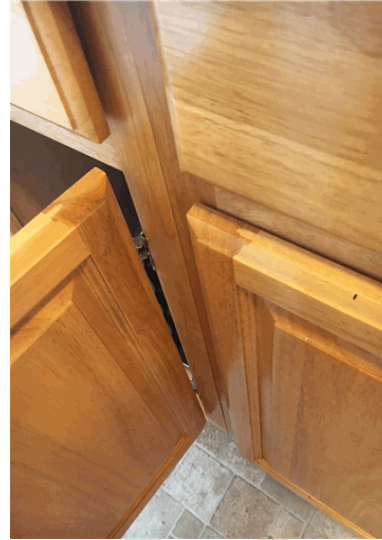
- 48) Counter Conditions AS The visible portion kitchen counters appeared to be in serviceable condition at the time of the inspection.
- 49) Cabinet Conditions R The cabinets were loose. Recommend securing or repair as needed for increased safety.

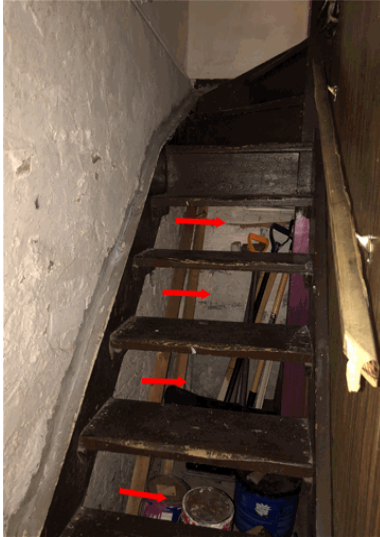
On a portion of the basement stairs "risers" were found not installed. Recommend installing risers for additional safety, as to avoid getting a foot caught in the open space. In addition, a small enough child may fall in between the space.

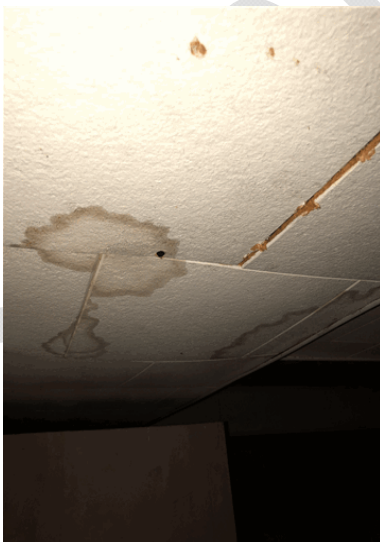
Moisture damage was observed on the ceiling (Northern portion of the Basement). Hidden damage may exist in areas not readily visible or accessible.

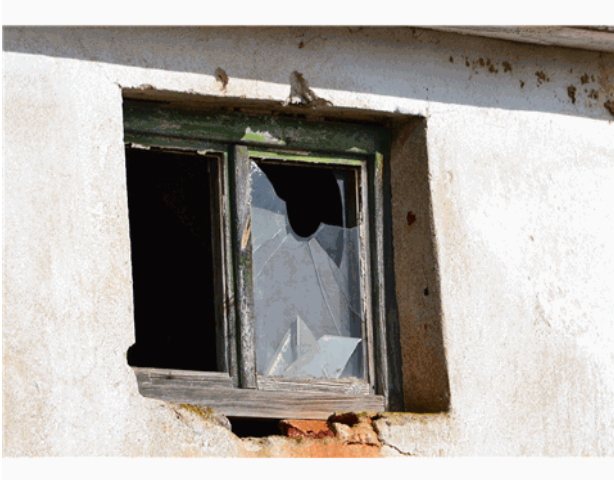
The basement window was found to be broken during the home inspection and should be repaired and/or replaced.

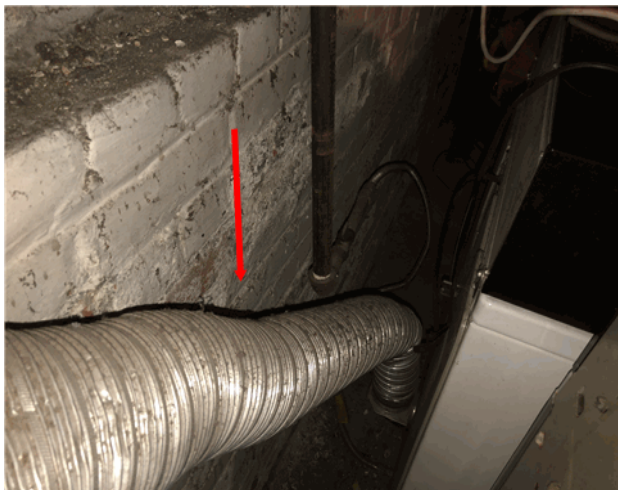
For increased fire safety, any flexible duct should be replaced with hard metal duct to reduce lint build up. The accumulation of lint can become a fire hazard. Cleaning is recommended on an annual basis.
